**FINAL REPORT**

**KAJIAN BAGI MENGGANTIKAN JAMBATAN SULTAN ISKANDAR  
DI FT001/639/90, KUALA KANGSAR, PERAK  
- THE STRUCTURAL ASSESSMENT AND REHABILITATION  
OF JAMBATAN SULTAN ISKANDAR**

**VOLUME 1 OF 4 : MAIN REPORT**

RPT/TC/275/14/40-FinalReport - Vol 1 of 4

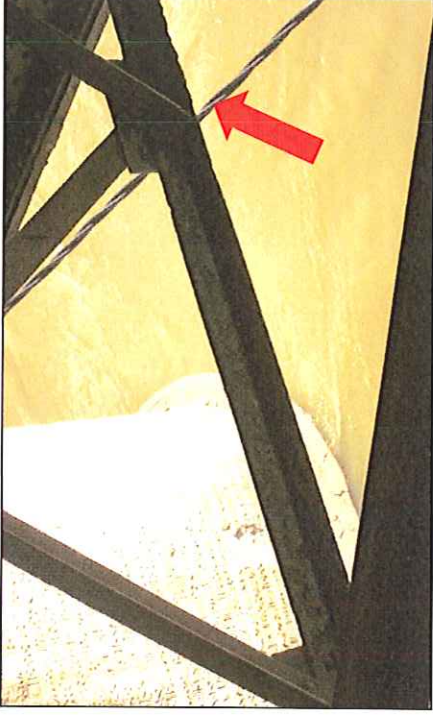
Picture M – S4 – P18

Minor corrosion on inclined cross bracing.

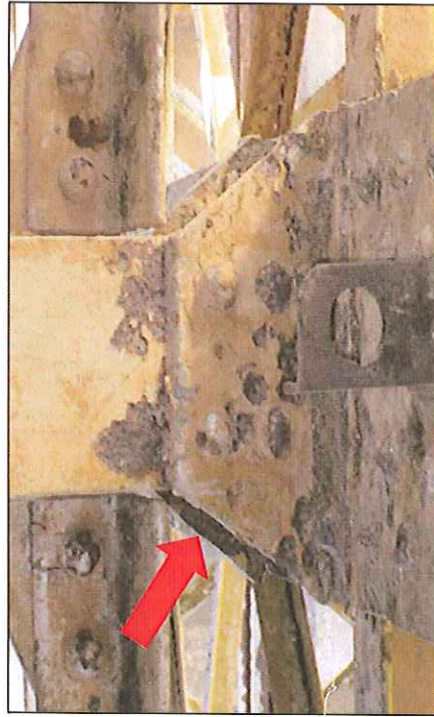
Picture M - S4 - P21

Minor corrosion on horizontal cross bracing.

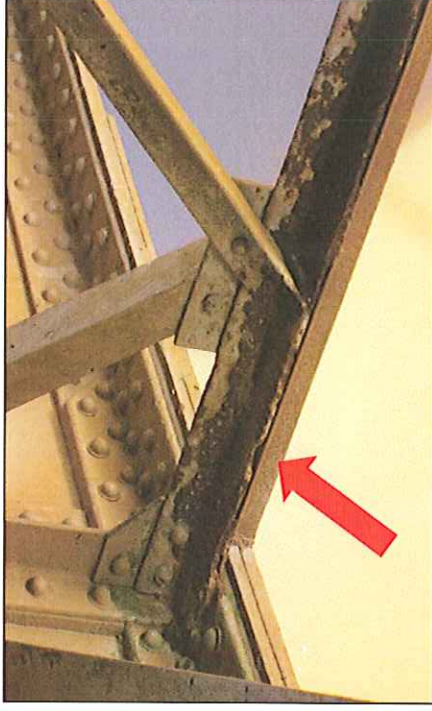
Picture M - S4 - P22

Moderate corrosion on vertical bracing joint of arch beam.

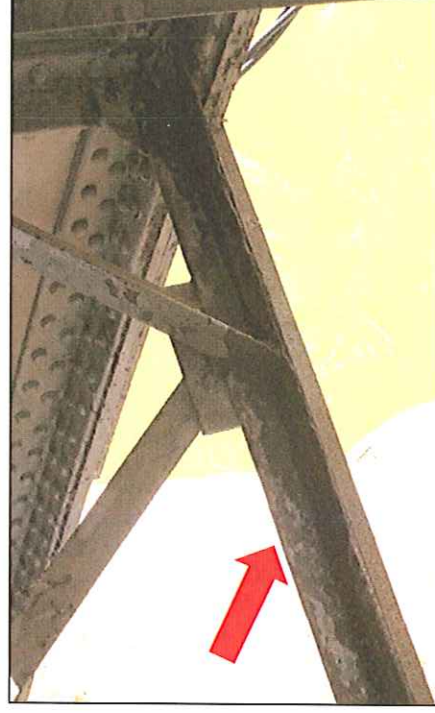
Picture M - S4 - P23

Moderate corrosion on inclined cross bracing.

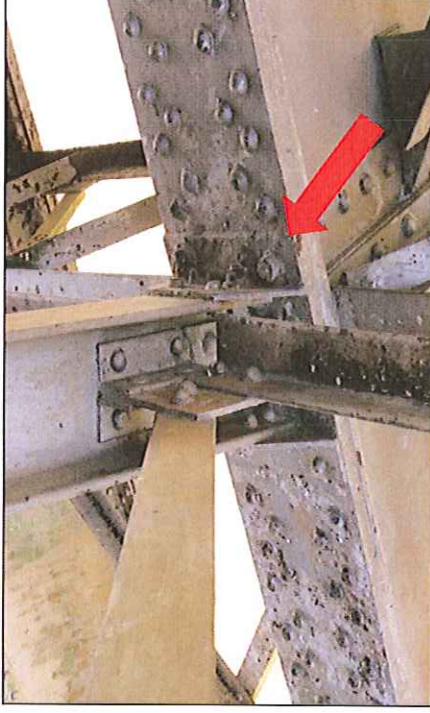
Picture M – S4 – P26

Moderate corrosion on vertical bracing joint of arch beam.

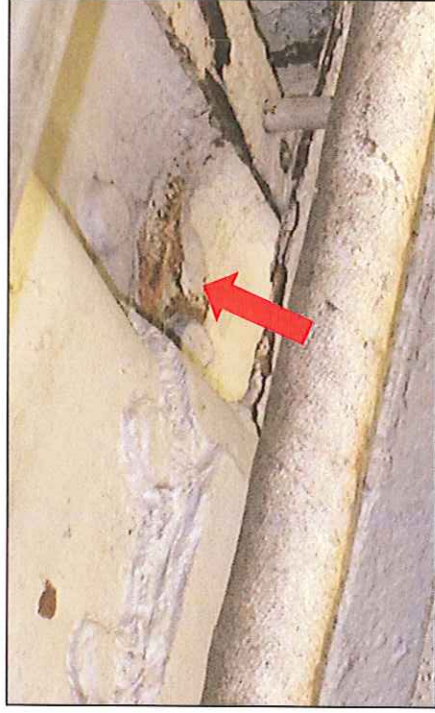
Picture M – S4 – P27

Moderate corrosion on vertical bracing joint of arch beam.

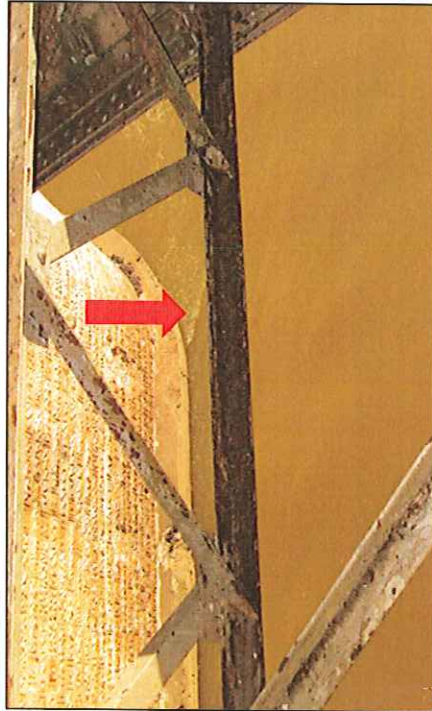
Picture M – S4 – P29

Minor corrosion with localized unused rivet holes on inclined cross bracing.

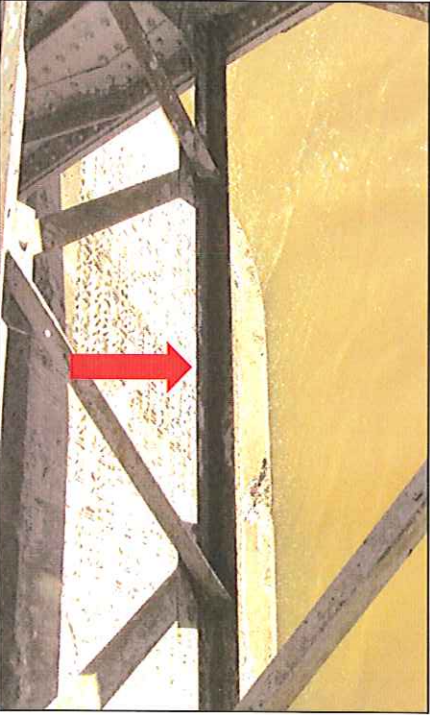
Picture M – S4 – P32

Moderate corrosion on inclined cross bracing.

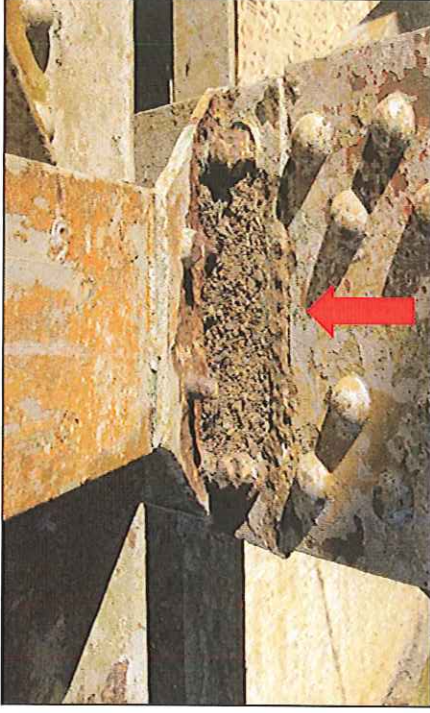
Picture M – S4 – P34

Minor corrosion on inclined cross bracing.

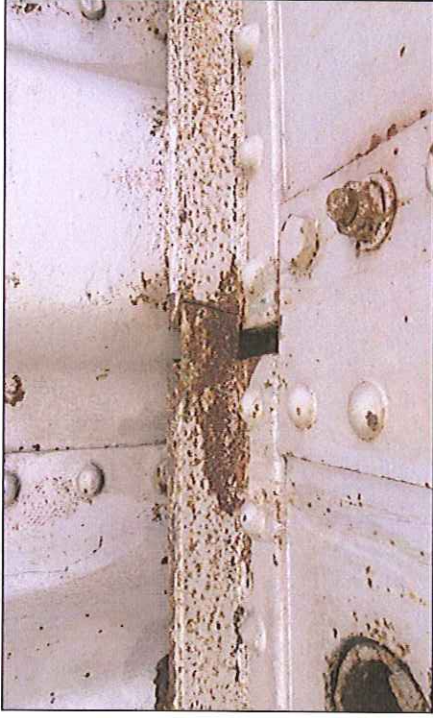
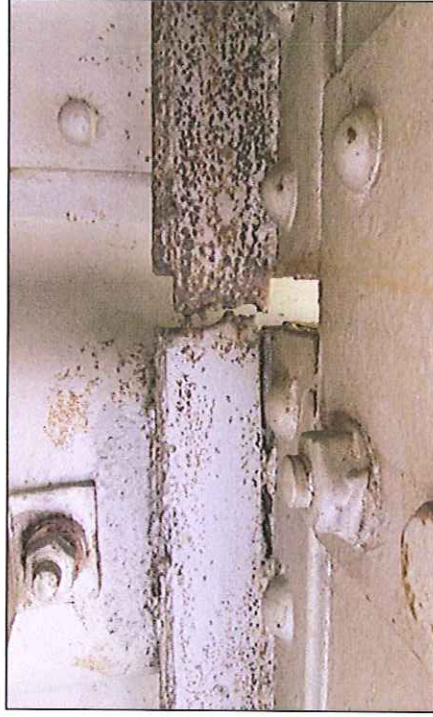
Picture M – S4 – P36

Minor corrosion and rivet missing on bottom flange of arch beam.

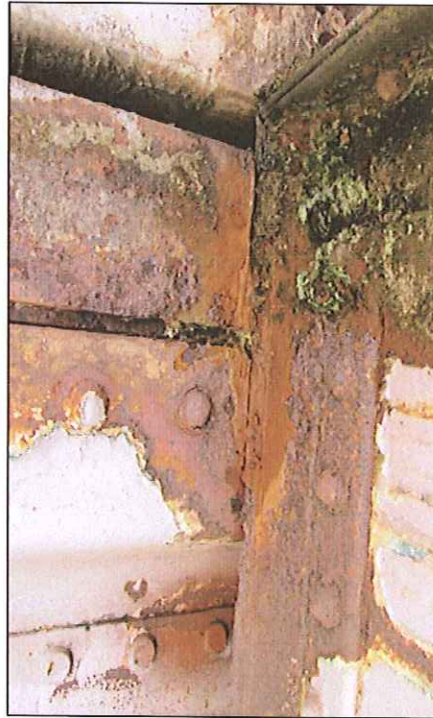
Picture M – S4 – P39 and M – S4 – P40

Moderate corrosion and crack line on steel plate.

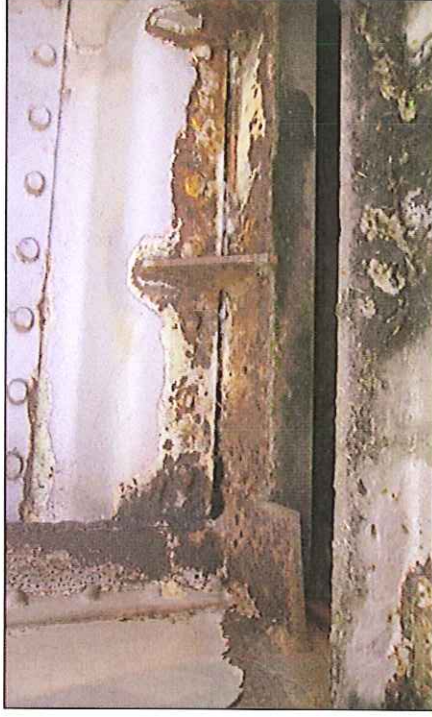
Picture M – S4 – P41 and M – S4 – P42

Moderate corrosion and crack line on steel plate.

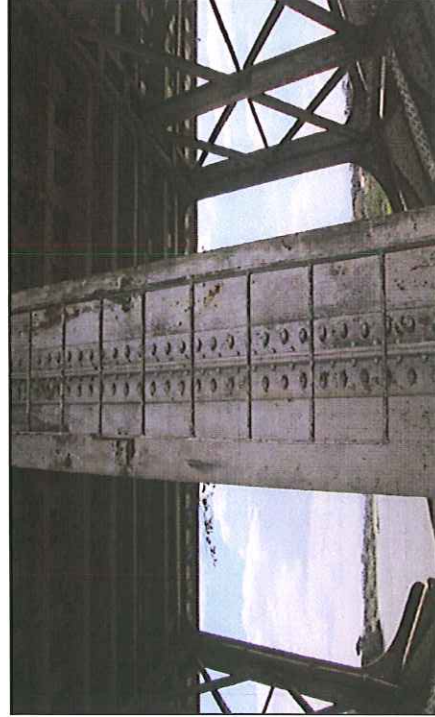
Picture M – S4 – P45

Moderate corrosion on overall middle frame.

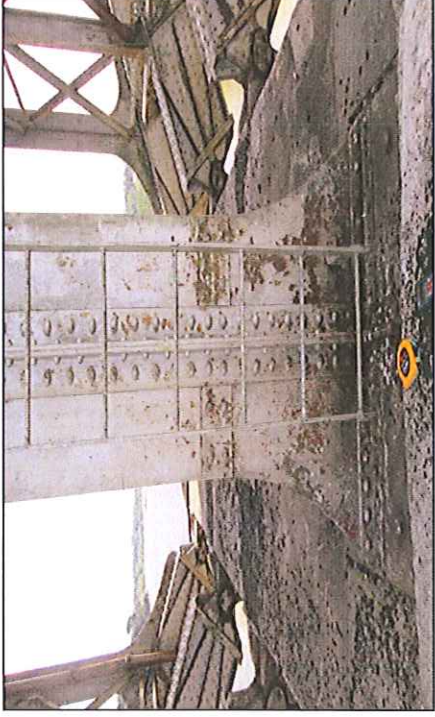
Picture M – S4 – P46

Minor corrosion on overall middle frame.

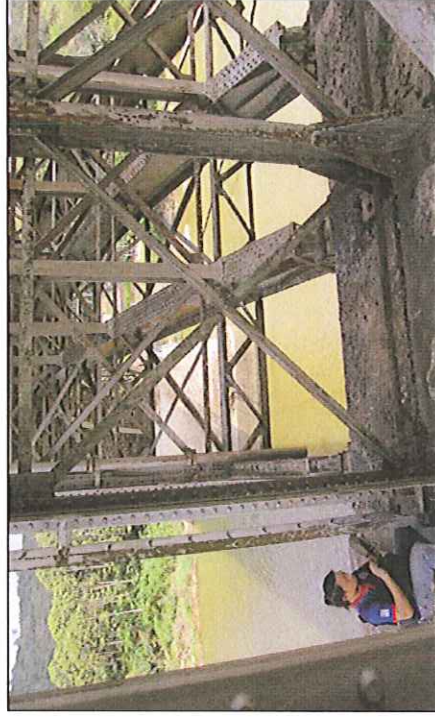
Picture M – S4 – P47

Minor corrosion on overall middle frame.

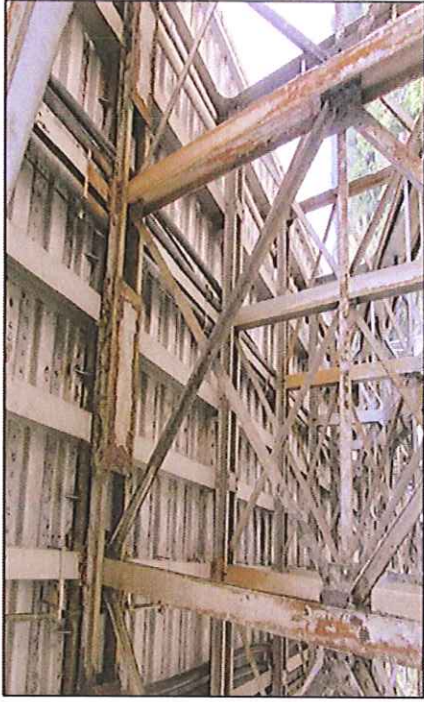
Picture M – S4 – P48

Minor corrosion on overall middle frame.

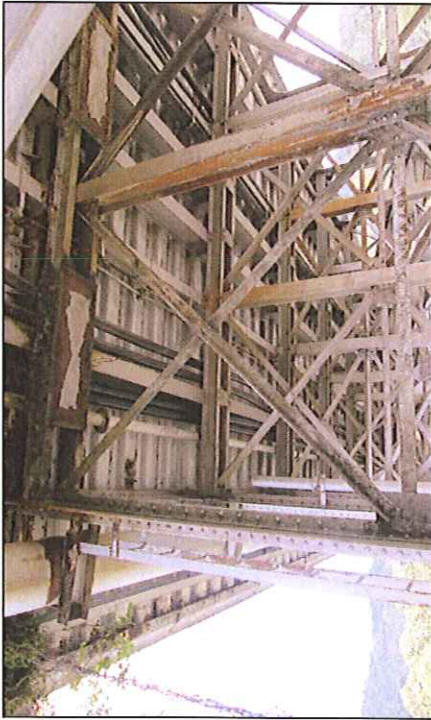
Picture M – S4 – P52

Minor corrosion on overall middle frame.

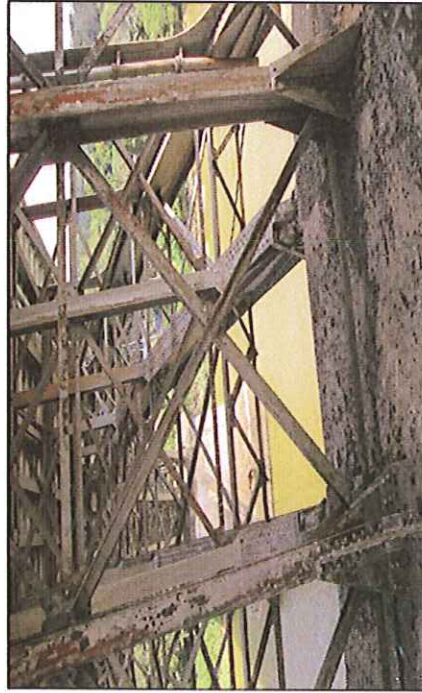
Picture M – S4 – P49

Moderate corrosion on overall middle frame.

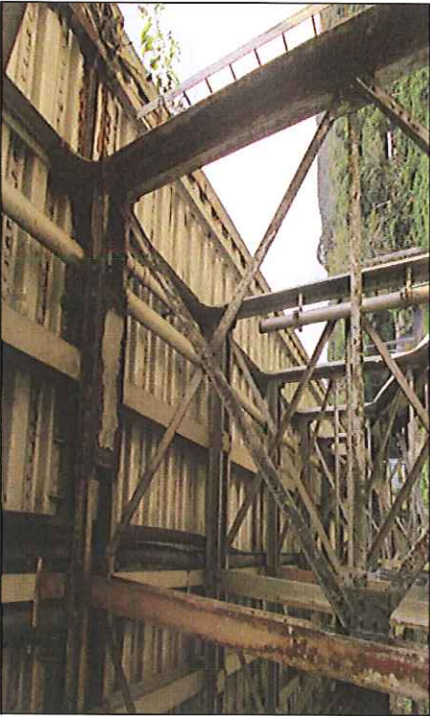
Picture M – S4 – P50

Minor corrosion on overall middle frame.

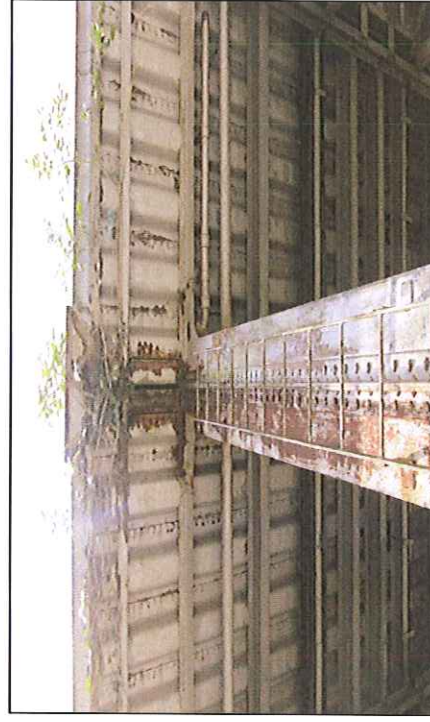
Picture M – S4 – P54

Minor corrosion on overall middle frame.

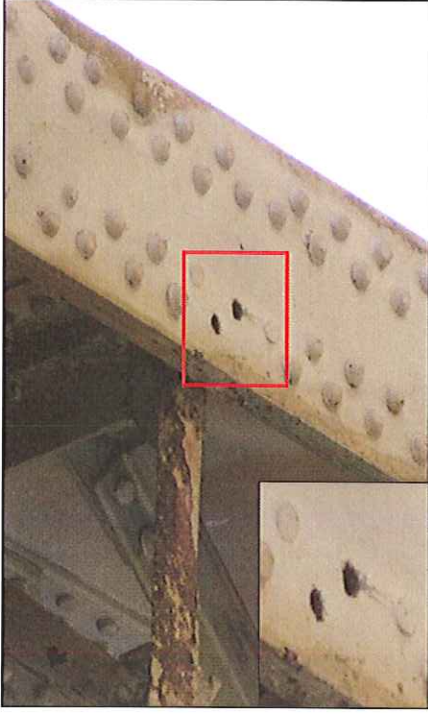
Picture M – S4 – P56

Moderate corrosion on overall middle frame.

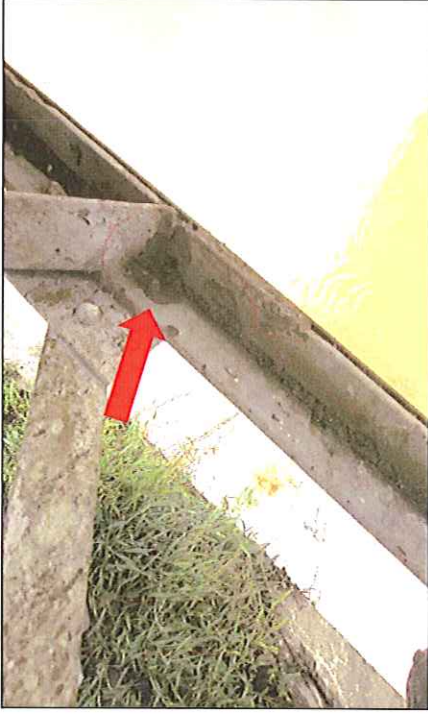
Picture M-S5-P3

Minor corrosion on inclined cross bracing.

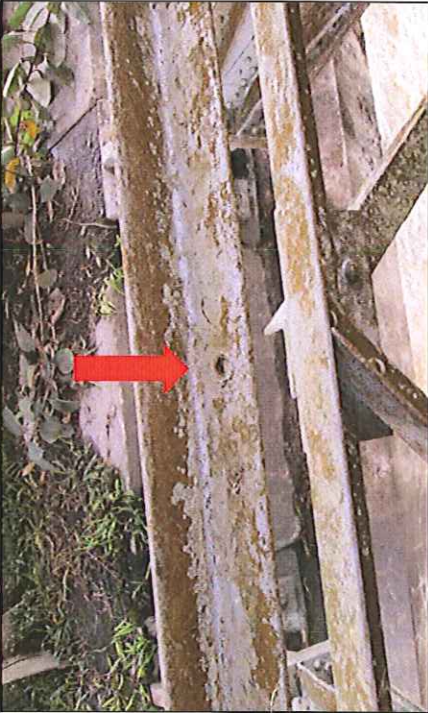
Picture M-S5-P1

Minor corrosion on top flange of arch beam.

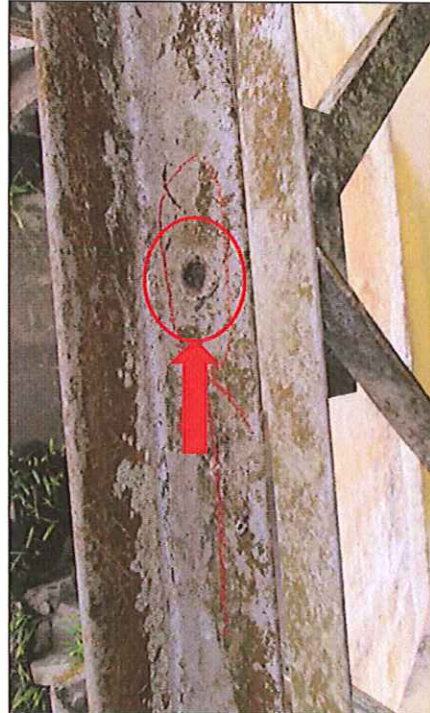
Picture M-S5-P2

Circular hole on top flange of arch beam.

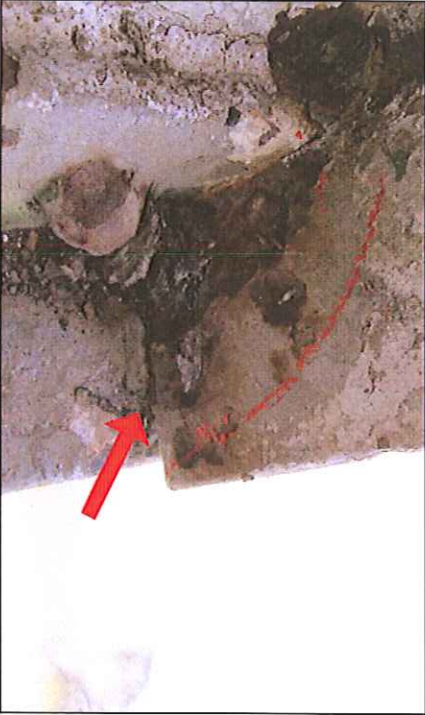
Picture M – SS – P5

Moderate corrosion on inclined cross bracing.

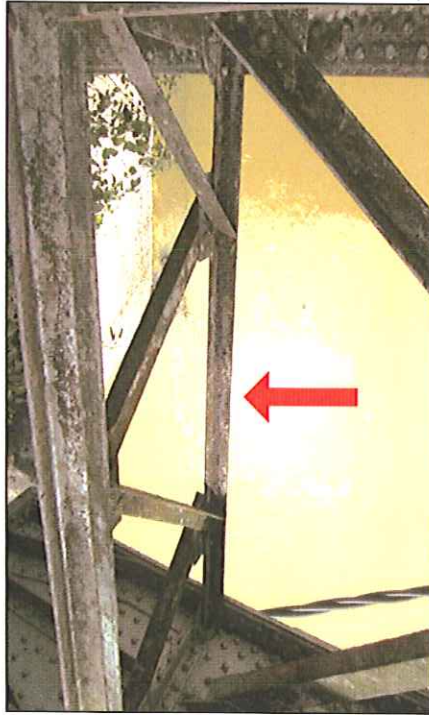
Picture M – SS – P6

Minor corrosion on inclined cross bracing.

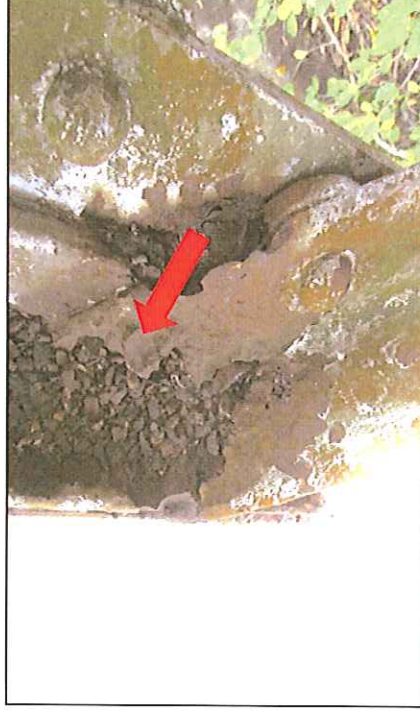
Picture M – SS – P8

Moderate corrosion on inclined cross bracing.

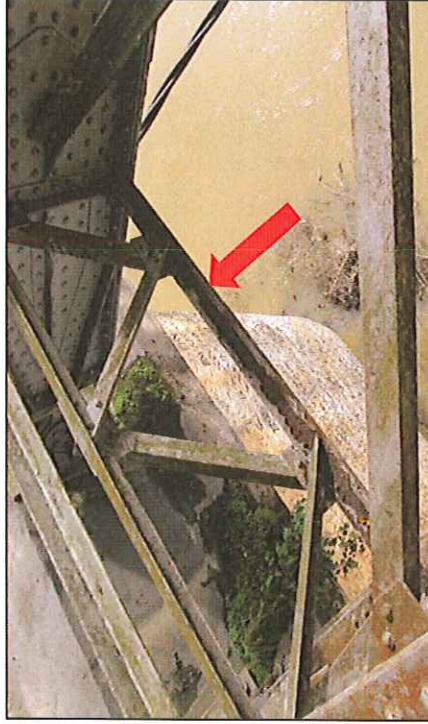
Picture M – S5 – P14

Minor corrosion on inclined cross bracing.

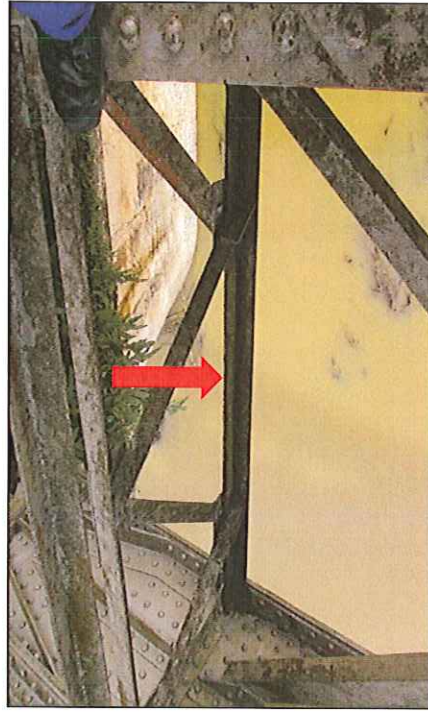
Picture M – S5 – P16

Minor corrosion on inclined cross bracing.

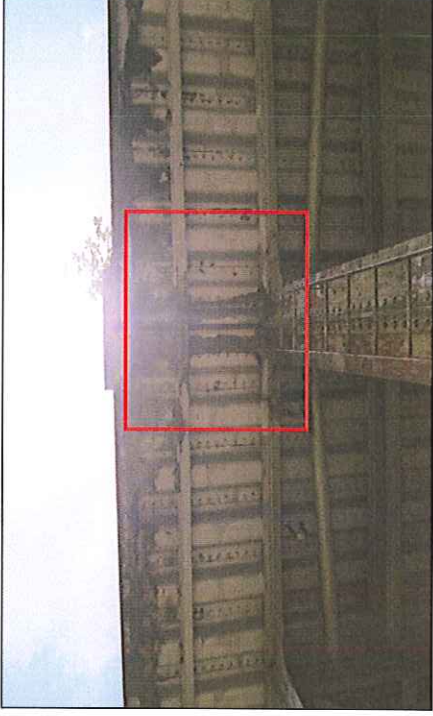
Picture M – S5 – P19 and M – S5 – P20  
Moderate corrosion and crack line on steel plate.

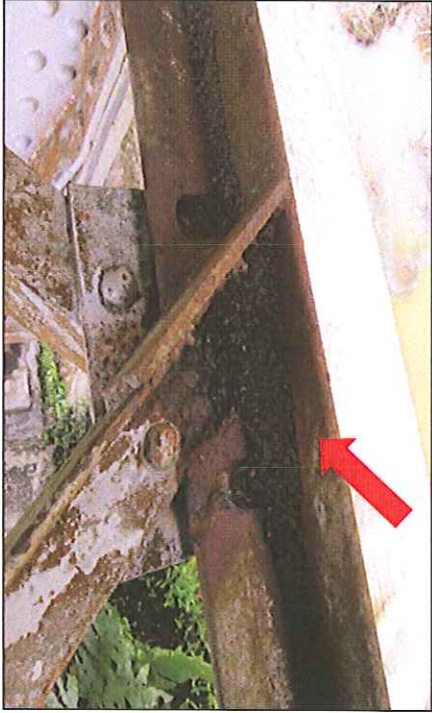
Picture M – S5 – P17  
Moderate corrosion and rivet head deteriorate on inclined cross bracing.

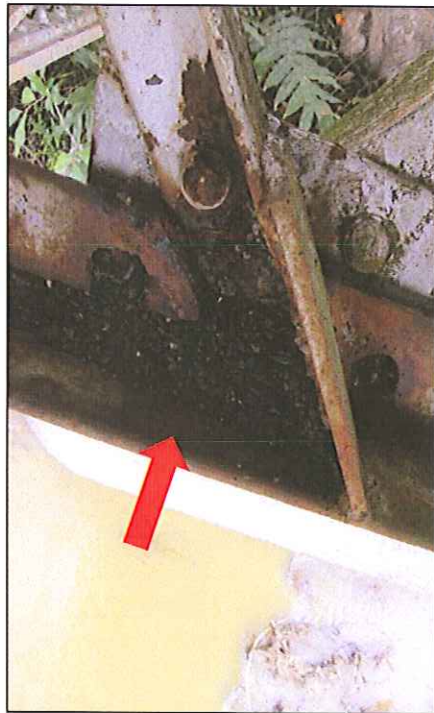
Picture M – S5 – P18  
Moderate corrosion and rivet head deteriorate on inclined cross bracing.

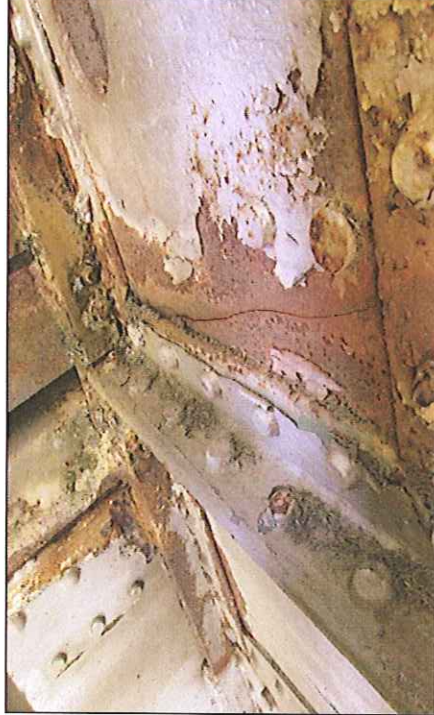
Picture M – S5 – P23 and M – S5 – P24

Moderate corrosion and crack line on steel plate.

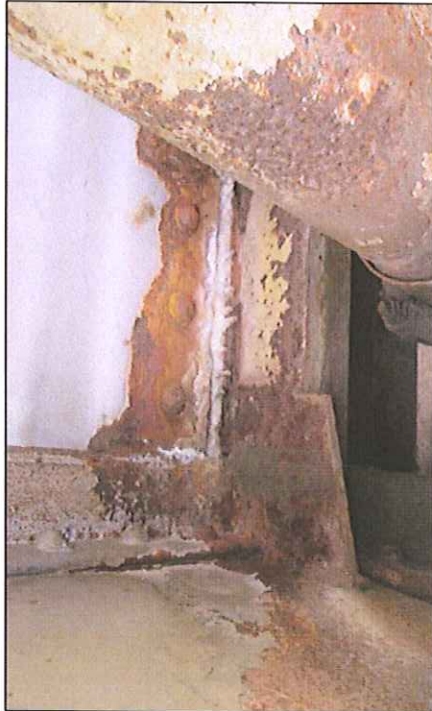
Picture M – S5 – P21 and M – S5 – P22

Moderate corrosion and crack line on steel plate.

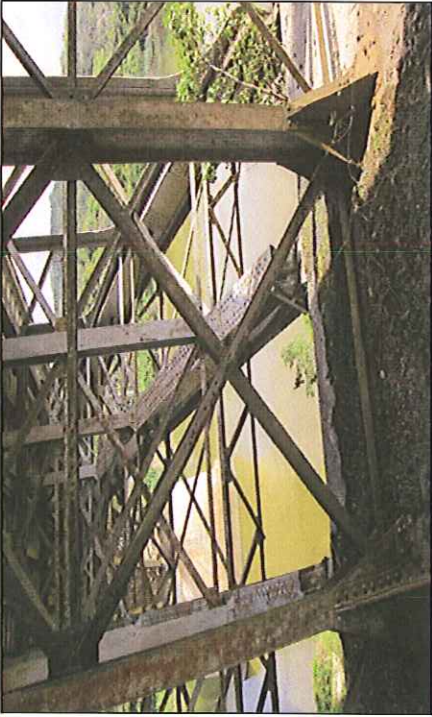
Picture M – S5 – P29

Minor corrosion on overall middle frame.

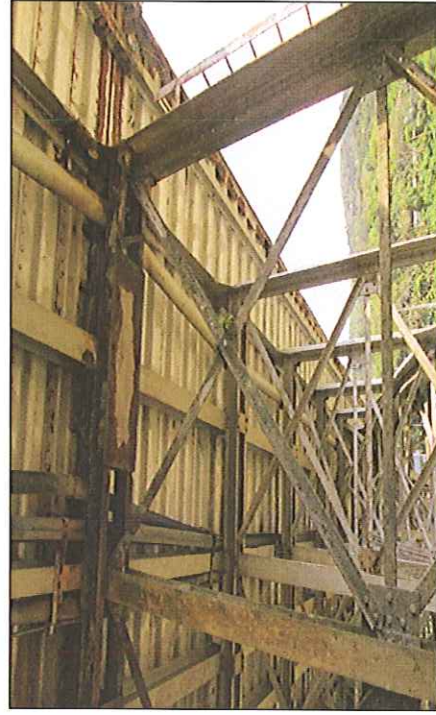
Picture M – S5 – P32

Moderate corrosion on overall middle frame.

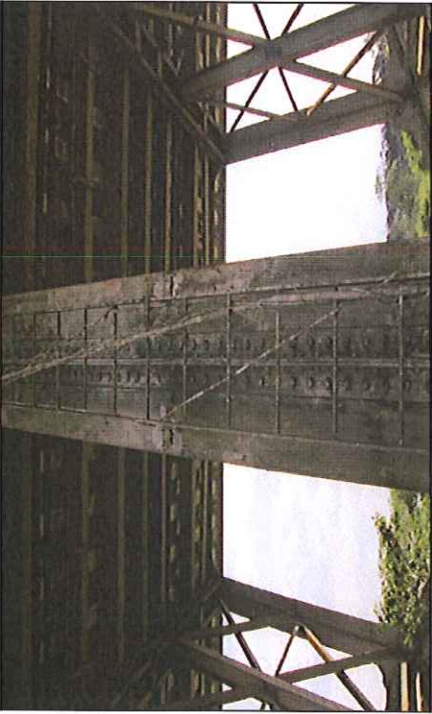
Picture M – S5 – P37

Minor corrosion on overall middle frame.

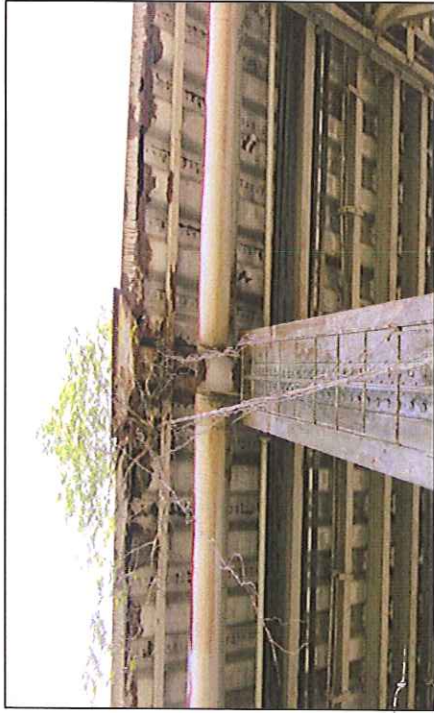
Picture M – S5 – P38

Moderate corrosion on overall middle frame.

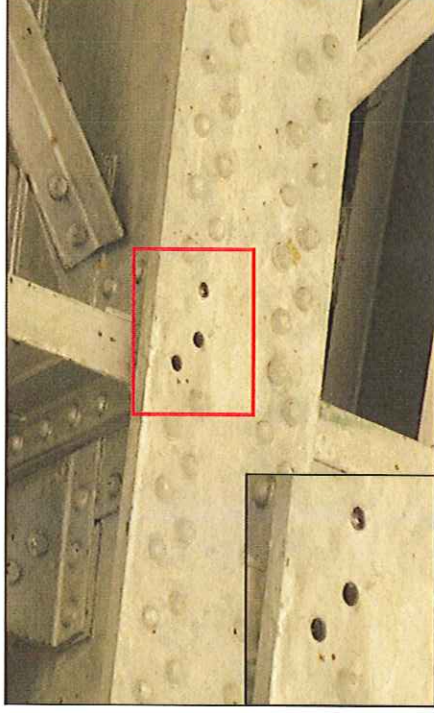
Picture M – S5 – P40

Missing rivet on bottom flange of arch beam.

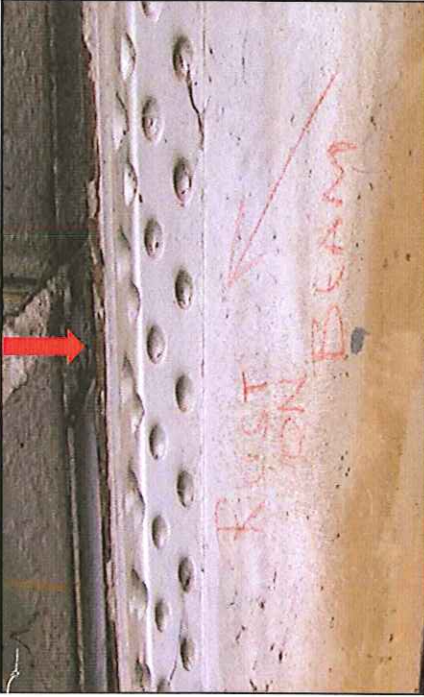
Picture M-S6-P1

Minor corrosion on top flange of arch beam.

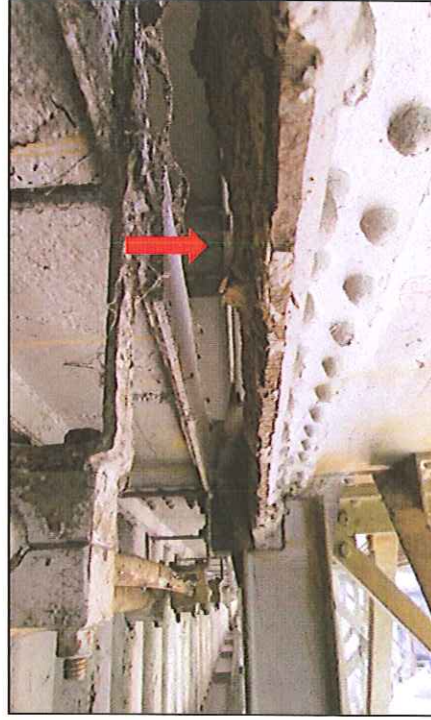
Picture M-S6-P2

Moderate corrosion on top flange of arch beam.

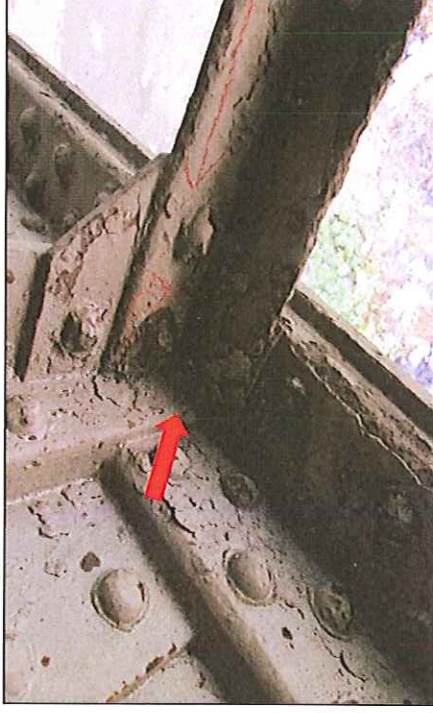
Picture M-S6-P3

Moderate corrosion on inclined cross bracing.

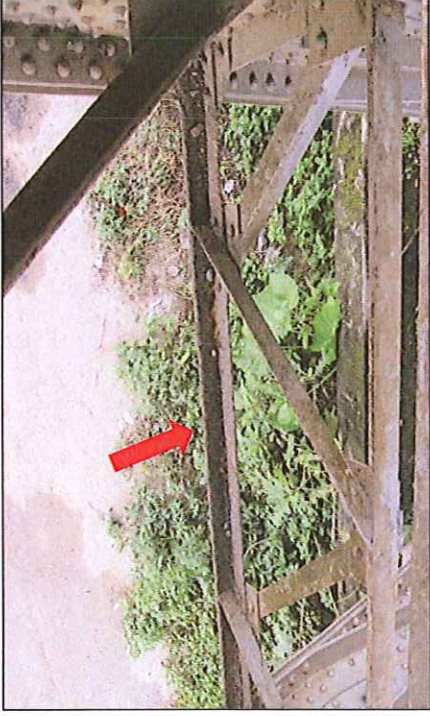
Picture M- S6 - P7

Minor corrosion on inclined cross bracing.

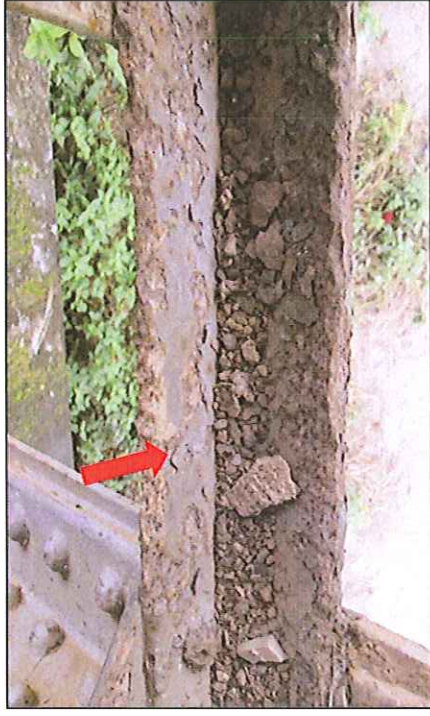
Picture M- S6 - P8

Moderate corrosion on inclined cross bracing.

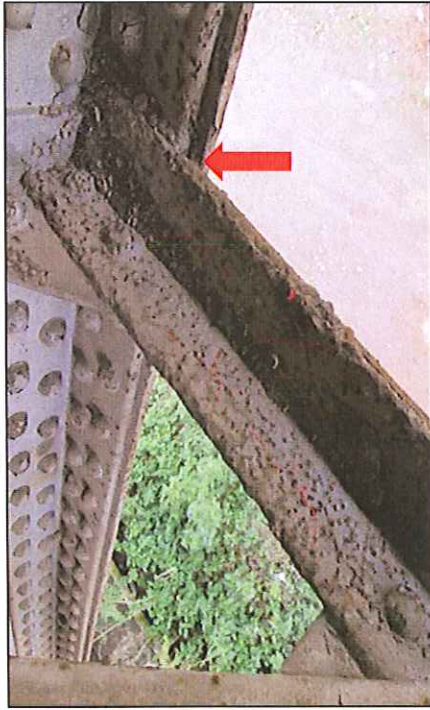
Picture M- S6 - P5

Minor corrosion on inclined cross bracing.

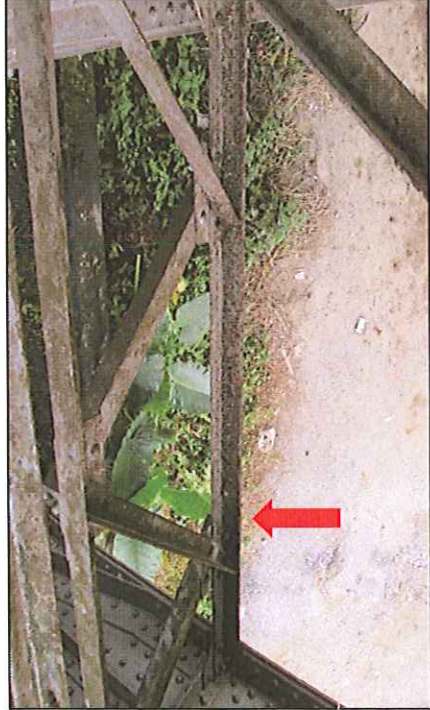
Picture M- S6 - P6

Minor corrosion on inclined cross bracing.

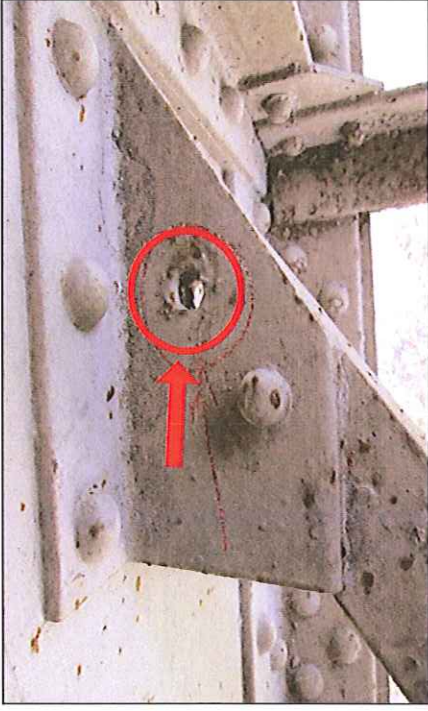
Picture M-S6-P11

Missing rivet on horizontal cross bracing of member.

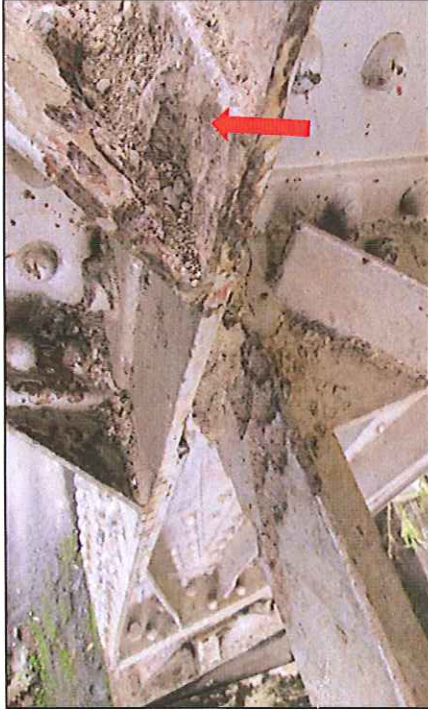
Picture M-S6-P9

Moderate corrosion on vertical bracing joint of arch beam.

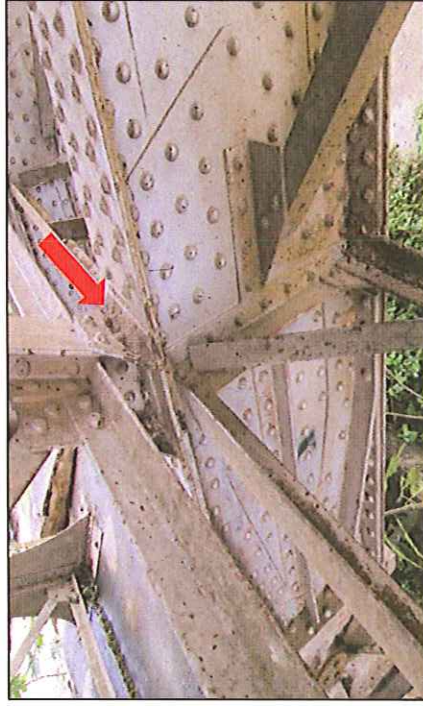
Picture M-S6-P10

Moderate corrosion on vertical bracing joint of arch beam.

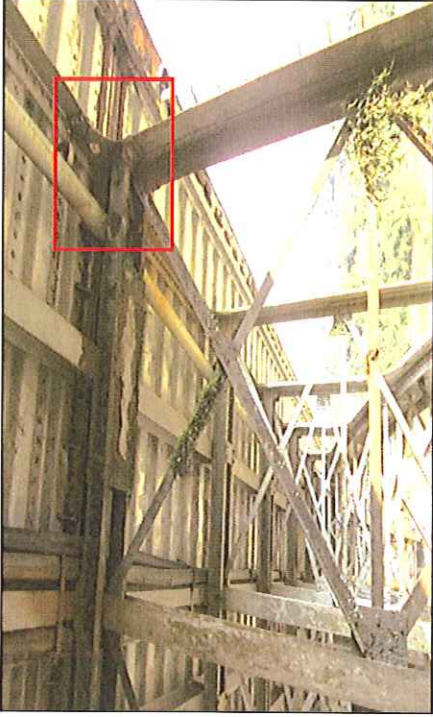
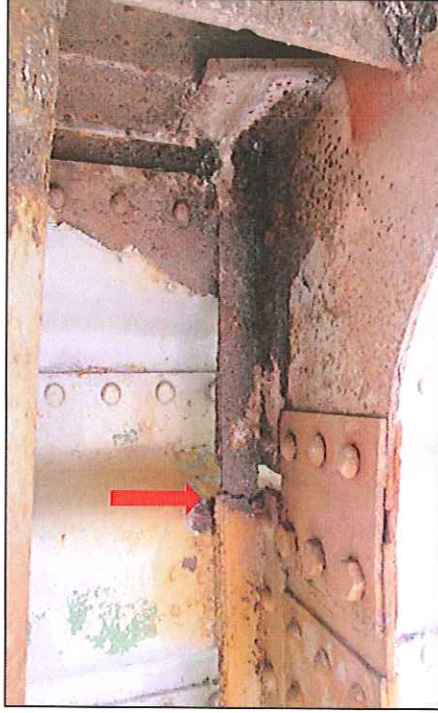
Picture M – S6 – P15 and M – S6 – P16

Moderate corrosion and crack on steel plate near expansion joint.

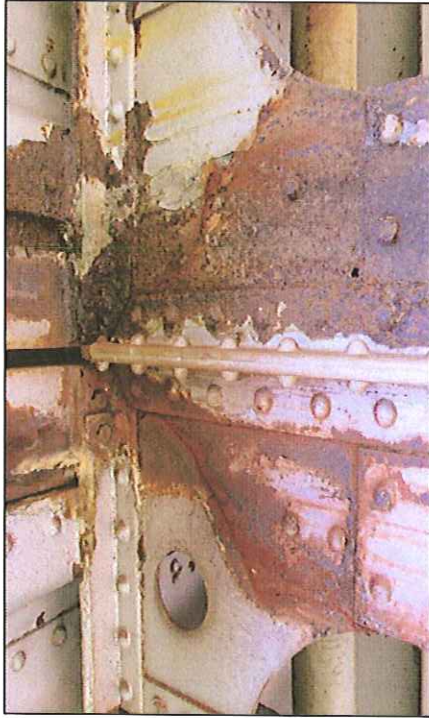
Picture M – S6 – P13 and M- S6 –P14

Moderate corrosion and crack line on steel plate near expansion joint.

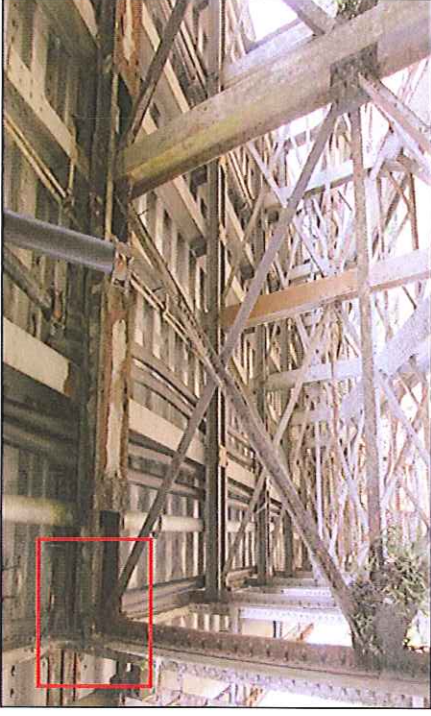
Picture M – S6 – P19 and M – S6 – P20  
Moderate corrosion on steel plate.

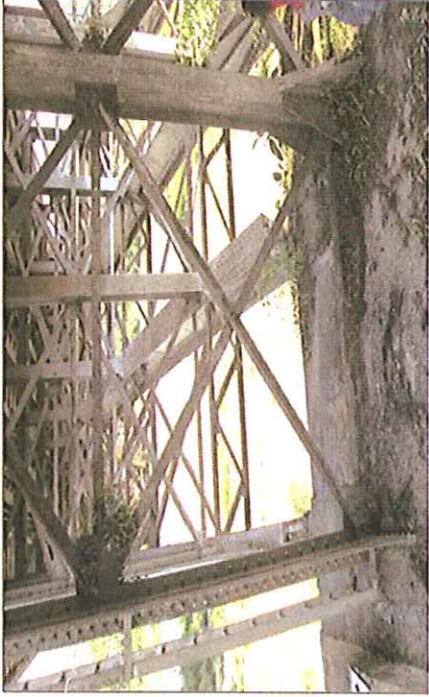
Picture M – S6 – P21

Minor corrosion on overall middle frame.

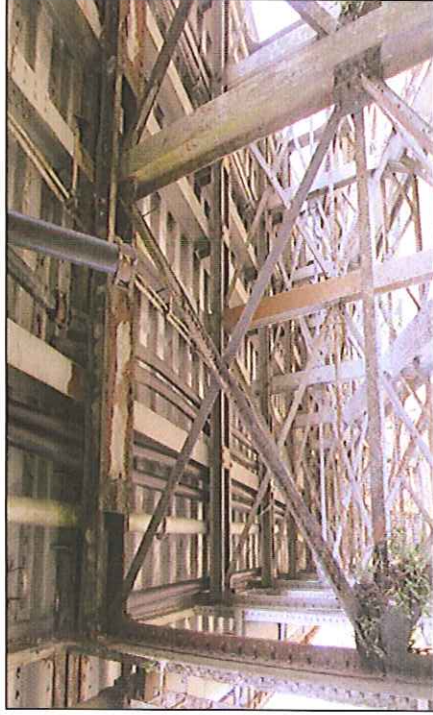
Picture M – S6 – P22

Moderate corrosion on overall middle frame.

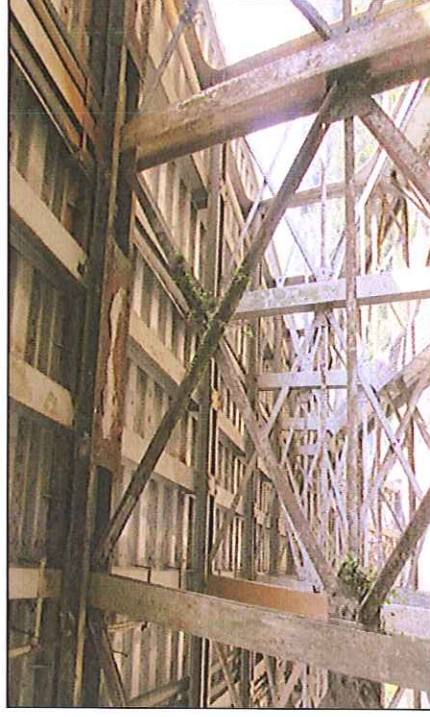
Picture M – S6 – P24

Moderate corrosion on overall middle frame.

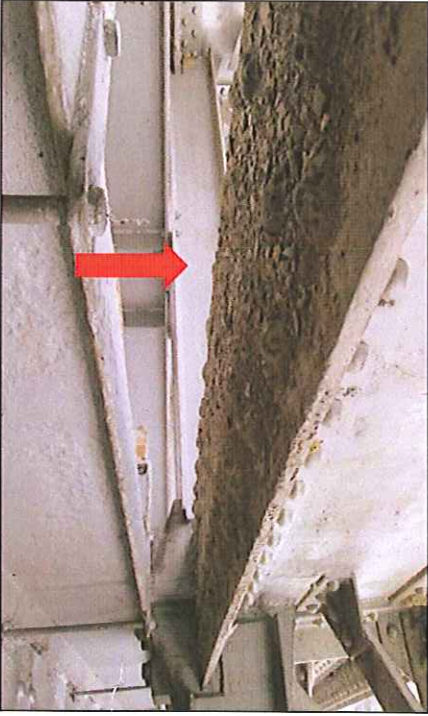
Picture M-S7-P1

Minor corrosion on top flange of arch beam.

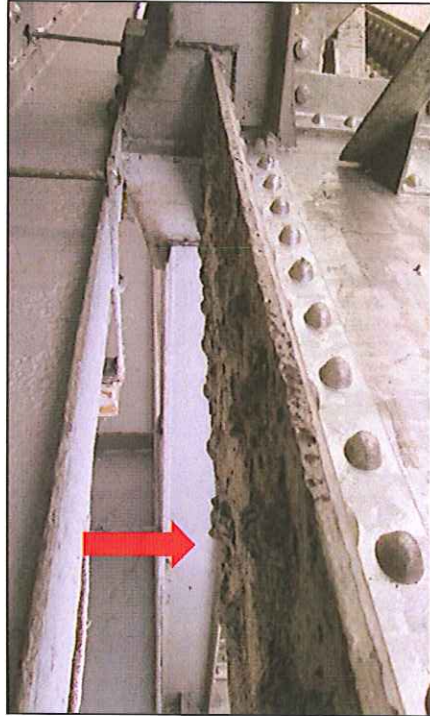
Picture M-S7-P2

Minor corrosion on top flange of arch beam.

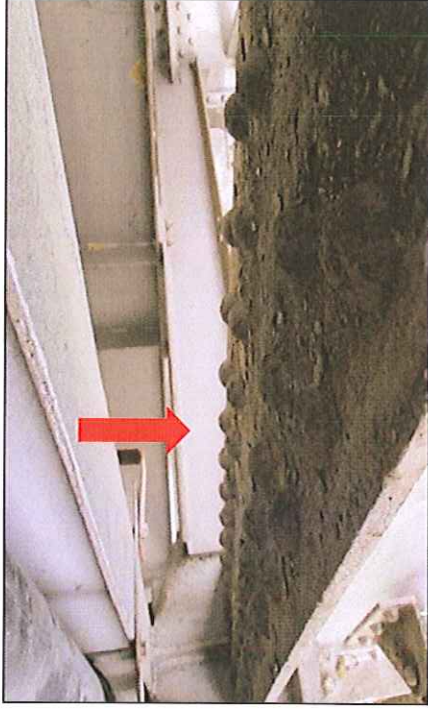
Picture M-S7-P3

Minor corrosion on top flange of arch beam.

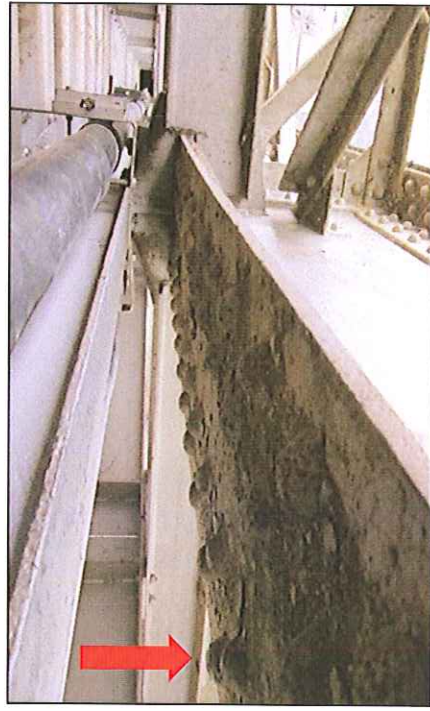
Picture M-S7-P4

Minor corrosion on top flange of arch beam.

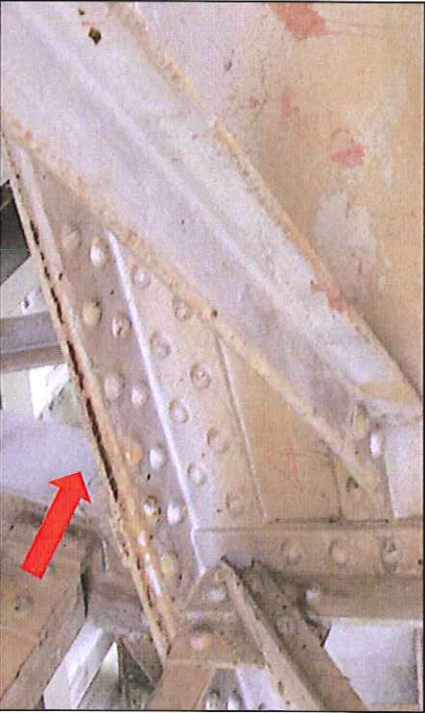
Picture M - S7 - P5

Minor corrosion on top flange of arch beam.

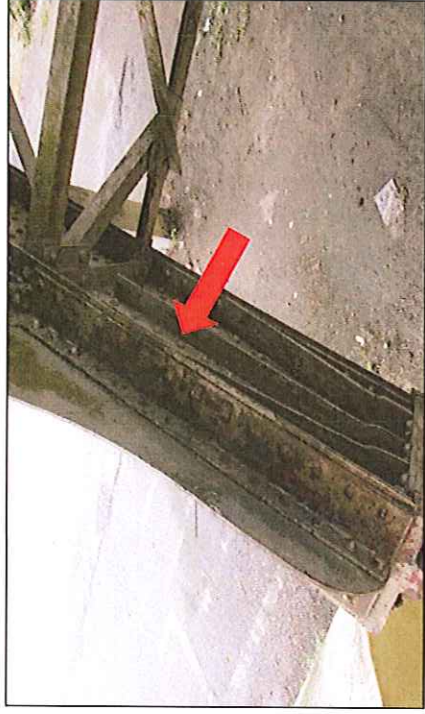
Picture M - S7 - P8

Minor corrosion on top flange of arch beam.

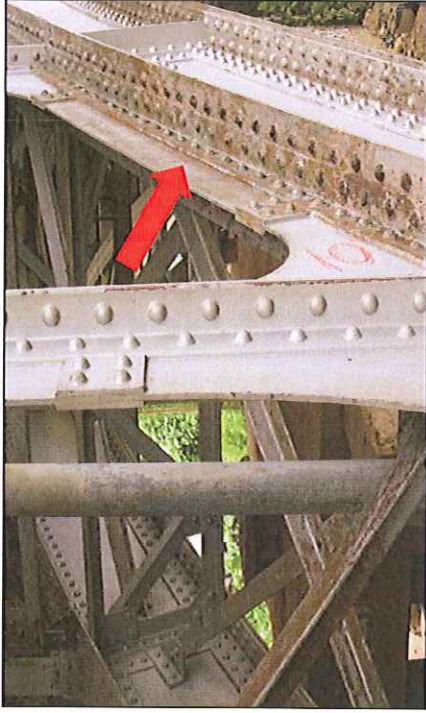
Picture M-S7-P11

Minor corrosion on top flange of arch beam.

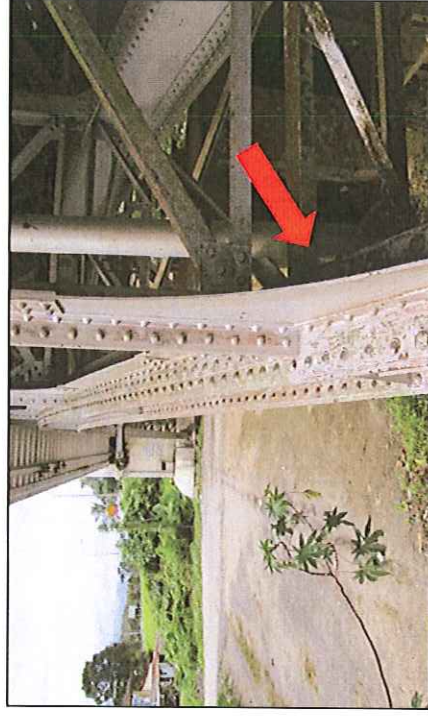
Picture M-S7-P12

Minor corrosion on top flange of arch beam.

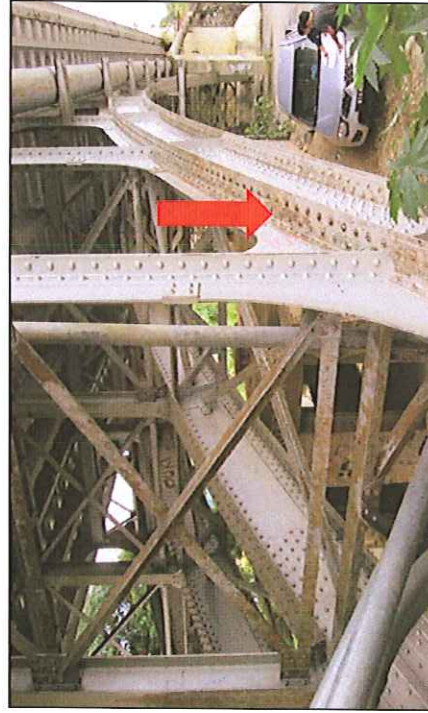
Picture M-S7-P10

Minor corrosion on top flange of arch beam.

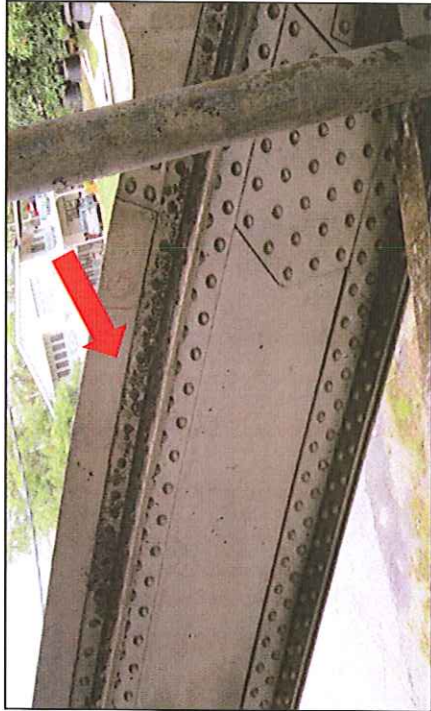
Picture M-S7-P14

Minor corrosion on top flange of arch beam.

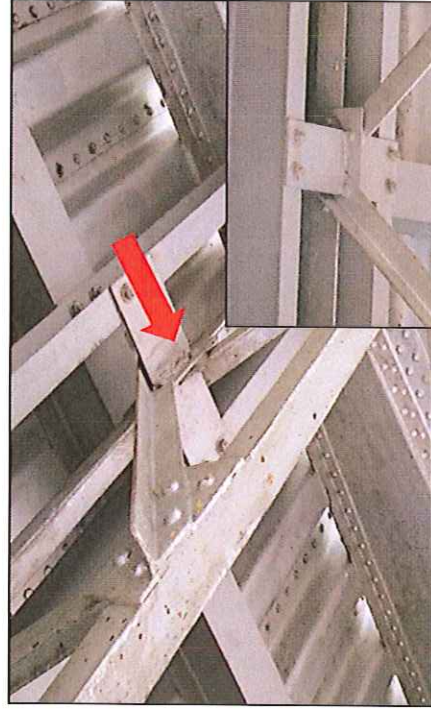
Picture M-S7-P16

Welding C-channel plate on inclined cross bracing.

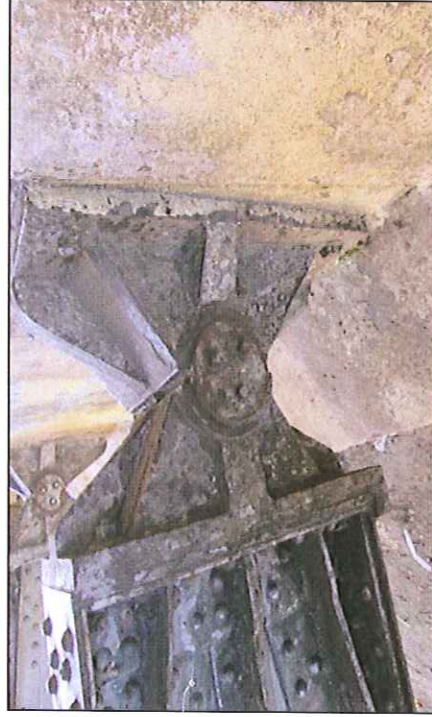
Picture M-S7-P18

Minor corrosion on end connection.

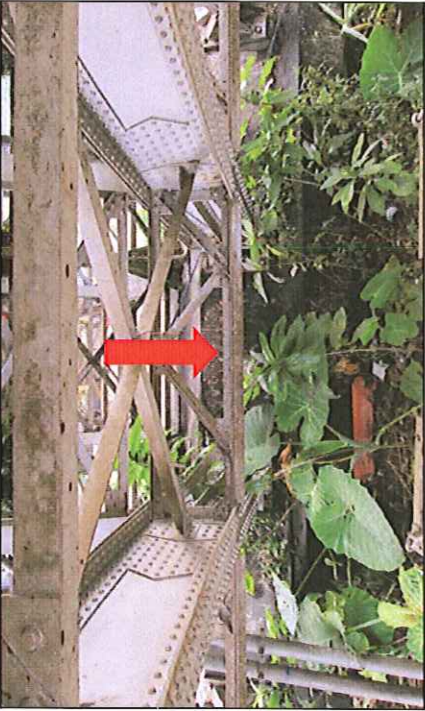
Picture M-S7-P21

Minor corrosion on inclined cross bracing.

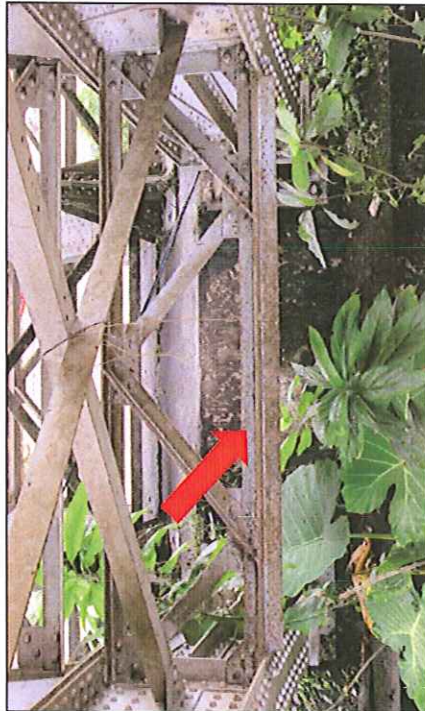
Picture M-S7-P22

Minor corrosion on inclined cross bracing.
