**FINAL REPORT**

**KAJIAN BAGI MENGGANTIKAN JAMBATAN SULTAN ISKANDAR  
DI FT001/639/90, KUALA KANGSAR, PERAK  
- THE STRUCTURAL ASSESSMENT AND REHABILITATION  
OF JAMBATAN SULTAN ISKANDAR**

**VOLUME 1 OF 4 : MAIN REPORT**

RPT/TC/275/14/40-FinalReport - Vol 1 of 4

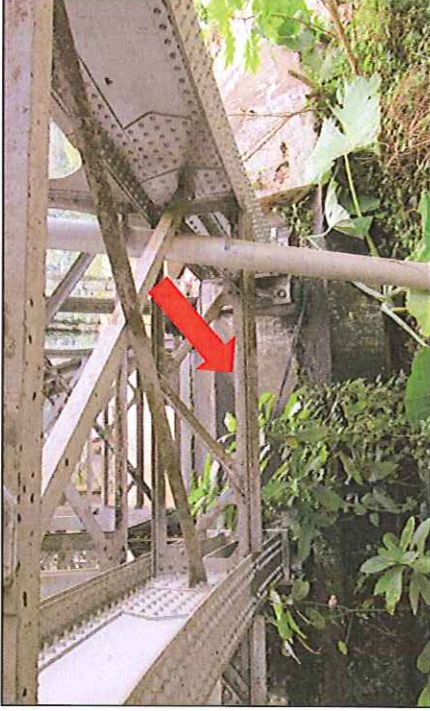
Picture M-S7-P23

Minor corrosion on inclined cross bracing.

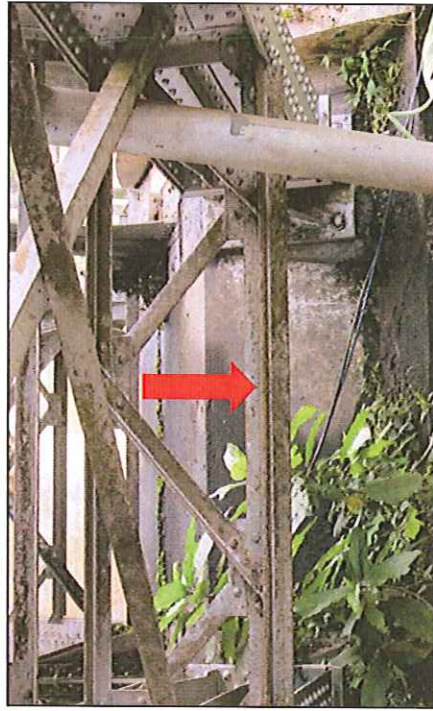
Picture M-S7-P24

Minor corrosion on inclined cross bracing.

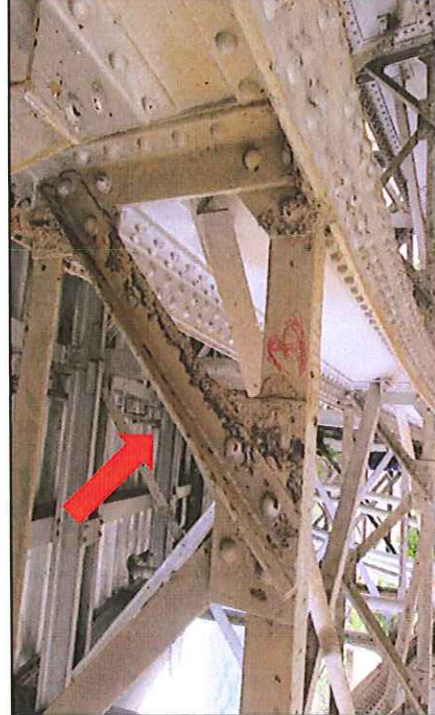
Picture M – S7 – P26

Minor corrosion on inclined cross bracing.

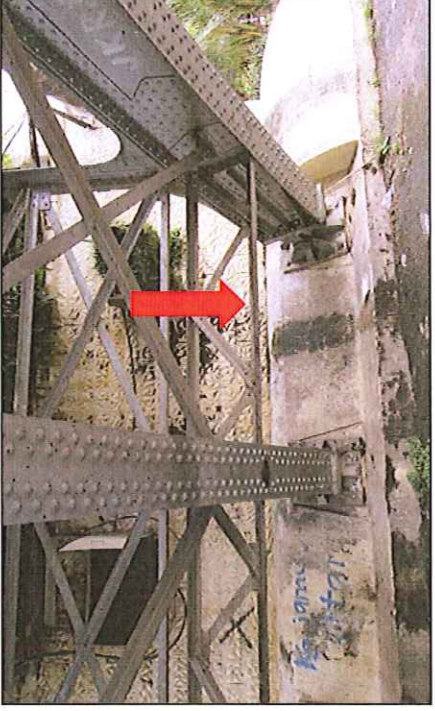
Picture M – S7 – P27

Minor corrosion on inclined cross bracing.

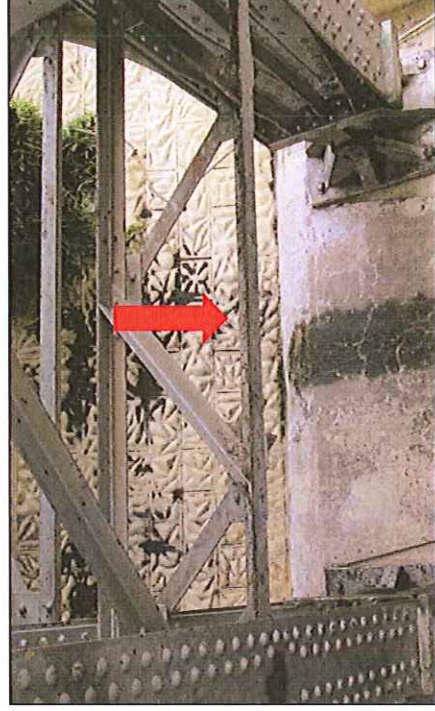
Picture M – S7 – P28

Minor corrosion on inclined cross bracing.

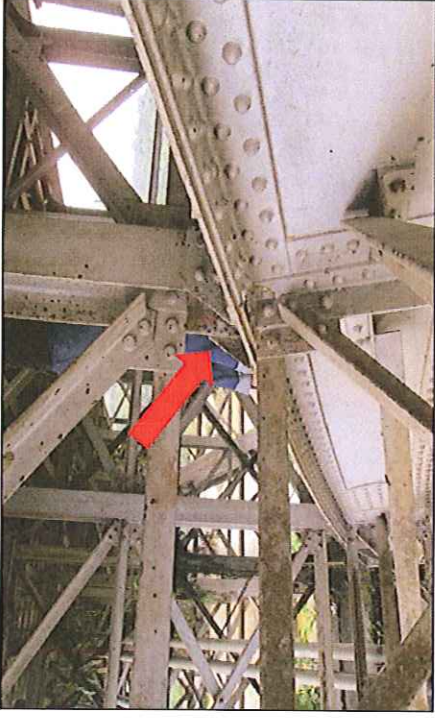
Picture M – S7 – P31

Minor corrosion on vertical bracing joint of arch beam.

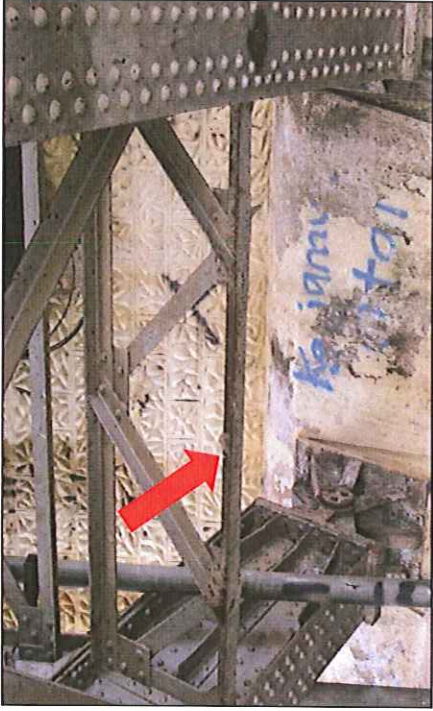
Picture M – S7 – P29

Minor corrosion on inclined cross bracing.

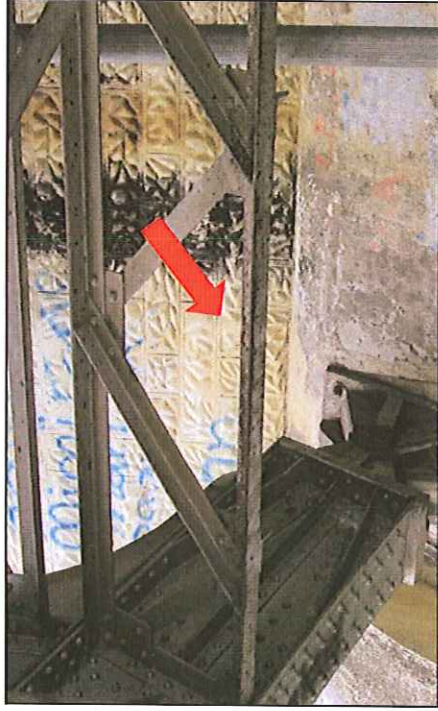
Picture M – S7 – P30

Minor corrosion on inclined cross bracing.

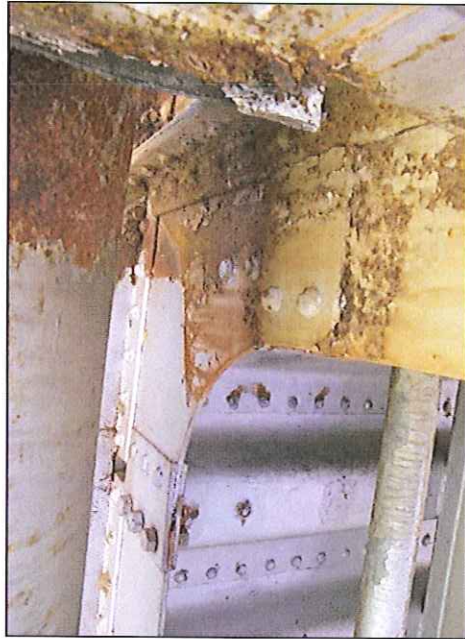
Picture M - S7 - P35 and M - S7 - P36

Moderate corrosion and crack line on steel plate.

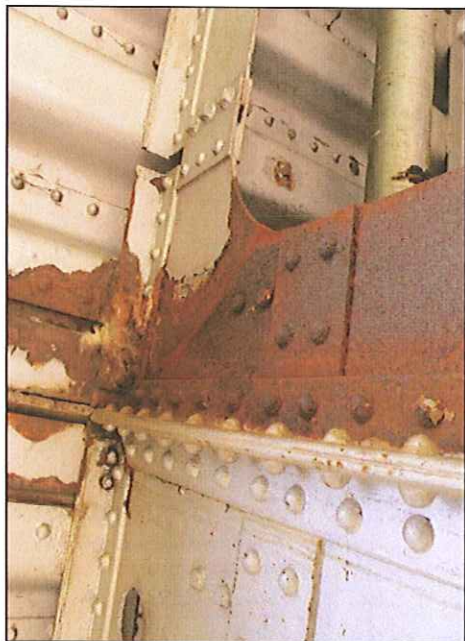
Picture M - S7 - P33 and Picture M - S7 - P34

Moderate corrosion and crack line on steel plate.

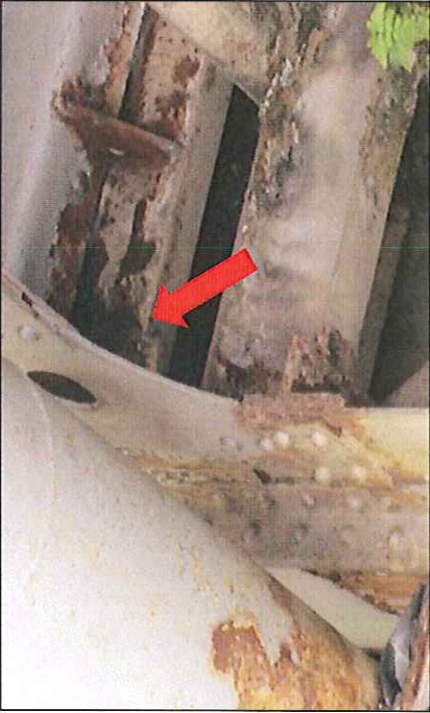
Picture M – S7 – P3Z

Moderate corrosion on T-beam.

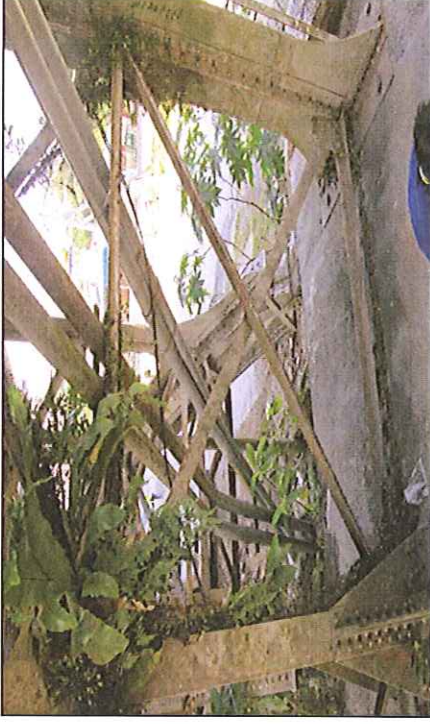
Picture M – S7 – P39

Minor corrosion on overall middle frame.

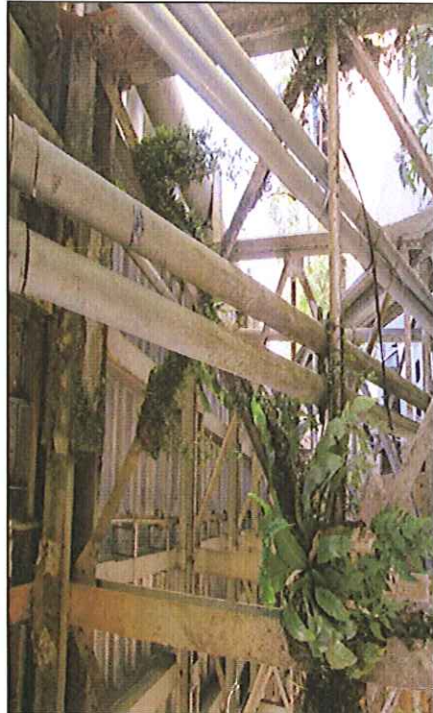
Picture M – S7 – P38

Moderate corrosion on overall middle frame.

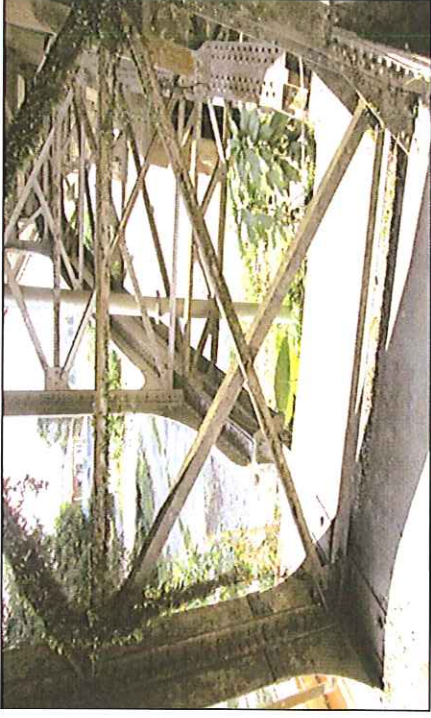
Picture M – S7 –P43

Minor corrosion on overall middle frame.

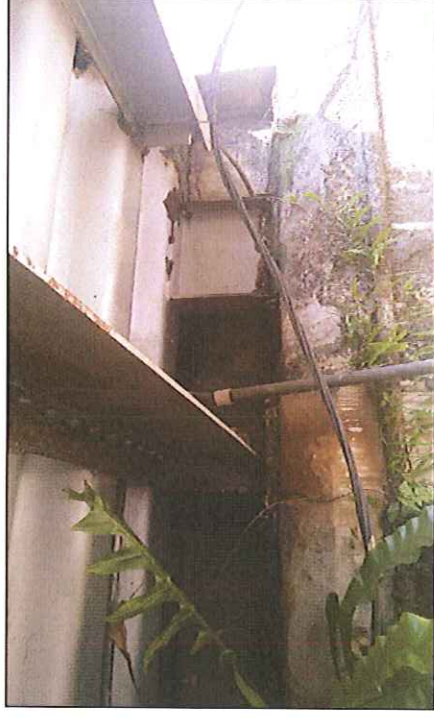
Picture M – S7 –P44

Moderate corrosion on abutment support.

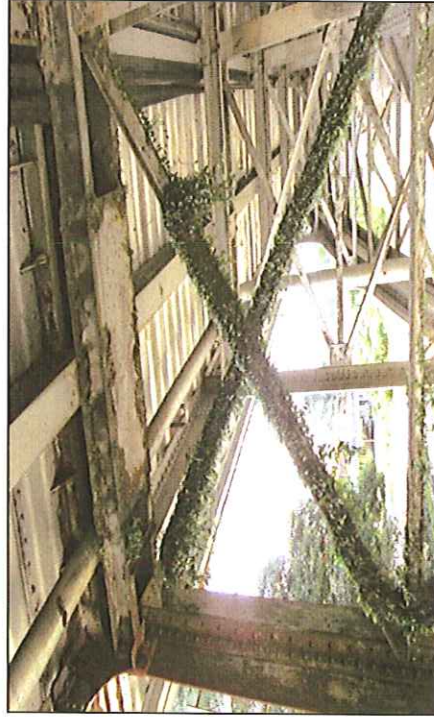
Picture M – S7 –P42

Moderate corrosion on overall middle frame.

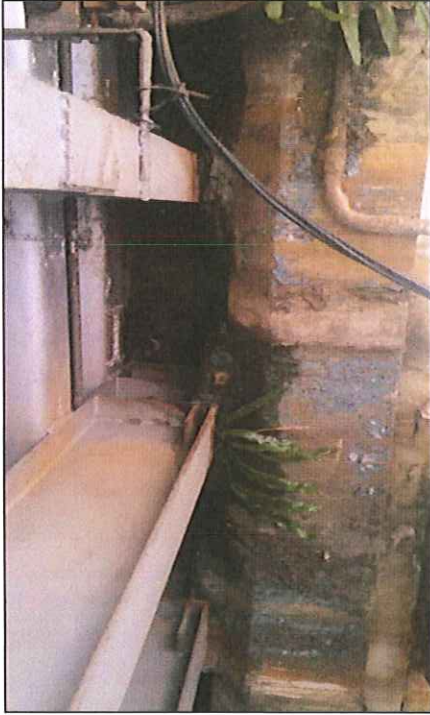
Picture M - S7 - P47

Moderate corrosion on abutment support.

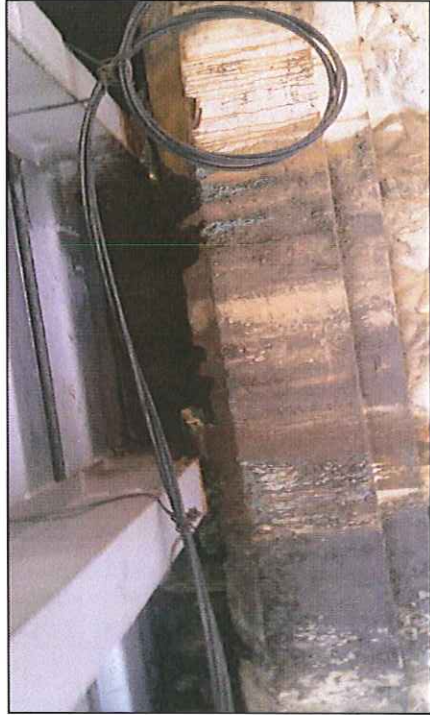
Picture M - S7 - P45

Moderate corrosion on abutment support.
